NASA TECHNICAL MEMORANDUM

PRELIMINARY INVESTIGATION
OF EFFECT OF ENVIRONMENTAL
FACTORS ON SALT STRESS CORROSION
CRACKING OF Ti-8A1-1Mo-1V
AT ELEVATED TEMPERATURES

by David N. Braski

Langley Research Center

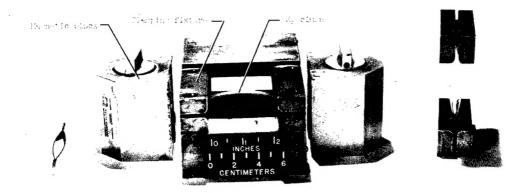
Figure 3.- Specimen, alinement fixtures, and clamping fixtures.

- (a) Specimen.
- (b) Alinement fixtures.
- L-64-7025.1 (c) Specimen with upper and lower clamping fixtures.

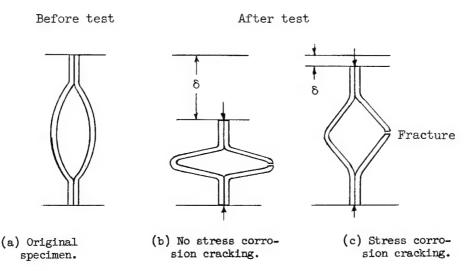
The effects of the various environments on the stress corrosion cracking in Ti-8Al-1Mo-1V were evaluated by the compression tests. Typical specimen configurations before and after compression testing are illustrated in figure 4. Specimens with no stress corrosion cracks could be compressed approximately 1.6 inches (4.1 cm) before fracture occurred at the bend (fig. 4(b)). Specimens with stress corrosion cracks fractured after relatively small amounts of shortening (fig. 4(c)). It was shown in reference 2 that the greater the maximum crack penetration, the smaller the amount of shortening needed to produce fracture. The following paragraphs are a discussion of the effects of different variables and environments on the stress corrosion cracking of Ti-8Al-1Mo-1V specimens stressed at 100 ksi (689 MN/m²). The results are shown graphically with specimen shortening at fracture, determined from the compression tests,

Figure 4.- Specimen configuration before and after room-temperature compression test. δ represents shortening.

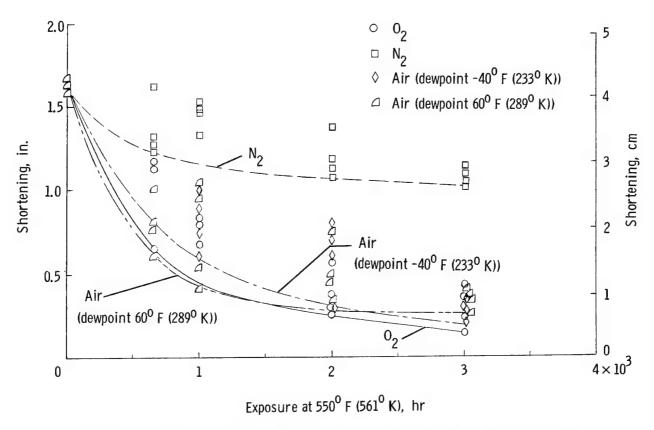
It is recognized that oxygen is an important factor in the stress corrosion mechanism in titanium alloys (see refs. 6, 7, and 8), but the effect of the amount and form of oxygen has not been established. The results of compression tests on specimens encapsulated in nitrogen, oxygen, moist air, and dry air (experiments 1, 2, 3, and 4 in table I), are shown in figure 5. These four environments contain three levels of gaseous oxygen: 0.002 percent (nitrogen), 100 percent, and 21 percent (air), by volume. The results show that the 100 percent oxygen, moist air, and dry air produced approximately the same amount of stress corrosion damage, whereas exposure in the nitrogen, with only 0.002 percent oxygen, produced less than one-half as much damage in the same time period

Figure 5 shows that specimens encapsulated in air with dewpoints of -40° F (233° K) and 60° F (289° K) displayed almost the same values of shortening with exposures up to 3000 hours. Therefore, moisture in this dewpoint range had little effect on stress corrosion cracking.

It is obvious from these results that oxygen is one of the main elements involved in the salt stress corrosion cracking of Ti-8Al-1Mo-1V. The author believes that with very small volumes of oxygen, the TiO₂ and/or TiO on the titanium surface also play an important role in the stress corrosion reactions. Kochka and Peterson, in reference 6, demonstrated that reacting TiO₂, NACl, and titanium together at elevated temperature without oxygen will produce the familiar blue-gray stress corrosion product. It appears, therefore, that the

Figure 5.- Effect of oxygen, nitrogen, dry air, and moist air on shortening of Ti-8Al-lMo-lV specimens after exposure at 550° F (561° K).

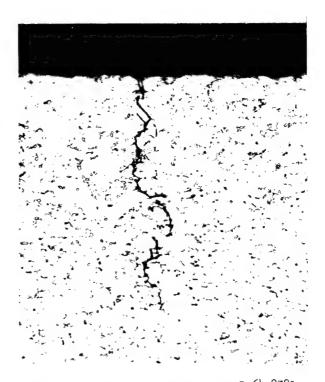
Figures 6 and 7 show photomicrographs of intergranular stress corrosion cracks in salt-coated specimens encapsulated in oxygen and in nitrogen and exposed for 3000 hours at 550° F (561° K). The cracks produced in the oxygen environment were more numerous and penetrated deeper into the base material than those produced in nitrogen.

L-64-8381
Figure 6.- Stress corrosion crack in
Ti-8Al-1Mo-1V specimen encapsulated
in oxygen for 3000 hours at 550° F
(561° K). ×500.

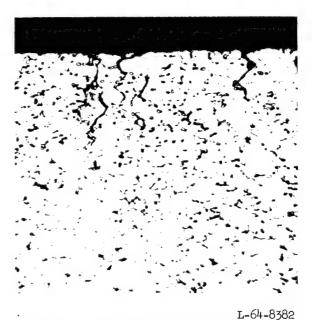
Figure 7.- Stress corrosion cracks in Ti-8Al-lMo-lV specimen encapsulated in nitrogen for 3000 hours at 550° F (561° K). ×500.

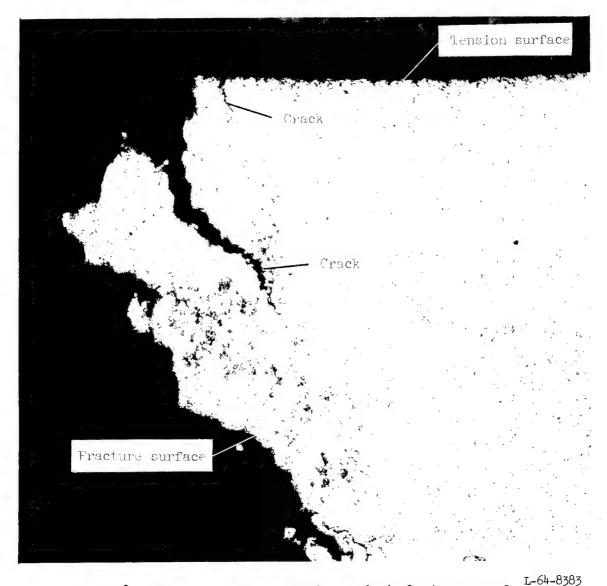
Moist chlorine gas was found to produce extremely severe stress corrosion in uncoated Ti-8Al-1Mo-1V at 550° F (561° K) (experiment 5 in table I). All of the specimens failed completely as a result of stress corrosion cracking before the 500-hour exposure time was reached. In every case, failure occurred at the intersection of the straight and bent portions of the specimens before removal from the oven. Figure 8 shows a photomicrograph of a stress corrosion failure area at one such intersection. Note the small intergranular cracks branching off of the main crack where failure occurred. The cracks were most numerous in

the vicinity of fracture and only a few were observed on the center portions of the specimen.

The specimens were covered with a dark purple corrosion product whose color and solubility properties in water are similar to those of TiCl3. Attempts to identify the products by X-ray diffraction failed as they were extremely hygroscopic. This experiment has shown that moist chlorine causes severe stress corrosion cracking, with a TiCl3 corrosion product, but it does not provide any clue as to the role of moisture in combination with chlorine.

Figure 8.- Edge view of stress corrosion cracks in fracture zone of Ti-8Al-lMo-1V specimen exposed in moist chlorine for 500 hours at 550° F (561° K). ×150.

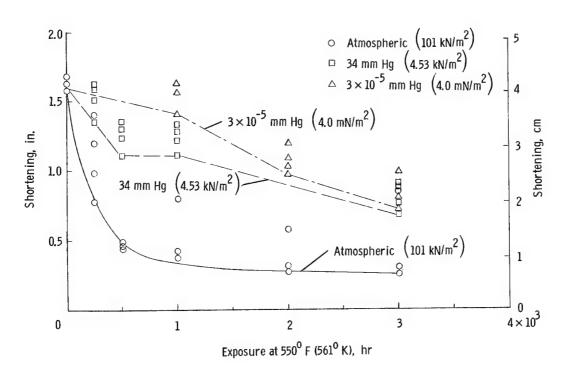
The effect of atmospheric (101kN/m²), 34 mm Hg (4.53 kN/m²), and 3×10^{-5} (4.0 mN/m²) pressure on the salt stress corrosion cracking of Ti-8Al-1Mo-1V (experiments 6, 7, and 8 in table I) is shown in figure 9. pressure of 34 mm Hg simulates the static pressure at an altitude of 70,000 feet (about 21,000 m), the approximate cruising altitude for a supersonic transport. Note that, as the pressure is reduced, the damage due to stress corrosion cracking is also reduced. This result generally agrees with tests reported in reference 8 on Ti-5Al-2.5Sn at various reduced pressures down to 1 micron (133 mN/m²) exposed at 800° F (700° K) for 1 hour. The reduction of stress corrosion cracking with lower pressure can be explained by the decreased amounts of oxygen available to the reaction.

Figure 9.- Effect of pressure on shortening of salt-coated Ti-8Al-lMo-lV specimens after exposure at 550° F (561° K).

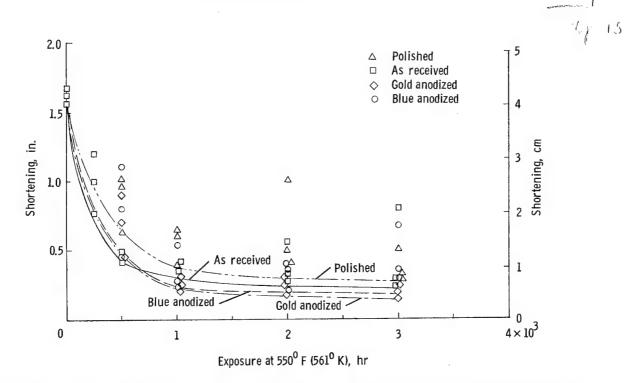
The results in figure 10 indicate that oxide films less than 600 angstroms do not noticeably affect stress corrosion cracking in Ti-8Al-1Mo-1V under the experimental conditions. However, data in reference 7 showed that a thicker gray oxide film (estimated from ref. 5 to be greater than 1000 Å) offered some protection against salt stress corrosion in Ti-6Al-4V exposed at 750° F (672° K) and 800° F (700° K) up to 50 hours.

Figure 10.- Effect of different surface conditions on shortening of salt-coated Ti-8Al-lMo-lV specimens after exposure at 550° F (561° K) in air.

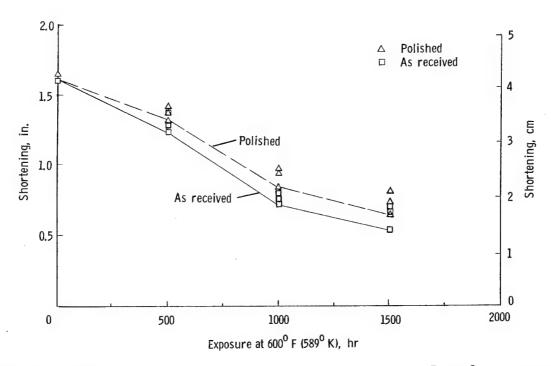
Figure 11.- Effect of surface condition at 3×10^{-5} mm Hg (4.0 \times 10⁻³ mN/m²) on shortening of salt-coated TI-8Al-lMo-lV specimens after exposure at 600° F (589° K).

As a further check on the effect of surface conditions, salt-coated specimens with polished and as-received surfaces were encapsulated separately under a pressure of 3×10^{-5} mm Hg (4.0 mN/m²) (experiments 12 and 13 in table I). Each capsule was heated to 600° F (589° K) while pumping down to insure the removal of moisture. The results in figure 11 indicate that polished specimens demonstrated slightly better resistance to stress corrosion cracking than did the as-received specimens. However, because of the limited number of specimens tested, it was difficult to draw any definite conclusions as to the relative effects of these two surface conditions. These tests do show that very little gaseous oxygen or surface oxide is necessary to produce stress corrosion cracks in Ti-8Al-1Mo-1V at 600° F (589° K).

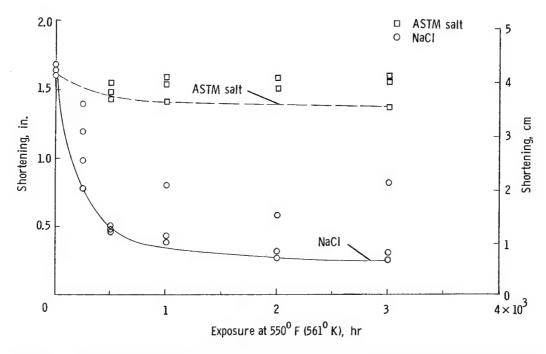
Figure 12.- Effect of salt composition on shortening of Ti-8Al-1Mo-1V specimens after exposure at 550° F (561° K).

The results for specimens with NaCl and ASTM salt coatings (experiments 6 and 14 in table I) are given in figure 12. For exposures up to 3000 hours at 550° F (561° K), the ASTM salt produced substantially less stress corrosion damage than the NaCl. This result was surprising since data from several investigations, such as reference 1, indicated that the effect of ASTM salt is probably more severe than that of NaCl. There seems to be no obvious explanation for this apparent inconsistency at this time. Additional stress corrosion tests are underway to determine the relative effects of NaCl, ASTM salt, and natural sea salt.
